# Intel<sup>®</sup> Pentium<sup>®</sup> III Processor Specification Update

Release Date: October 2004

Document Number: 244453-050

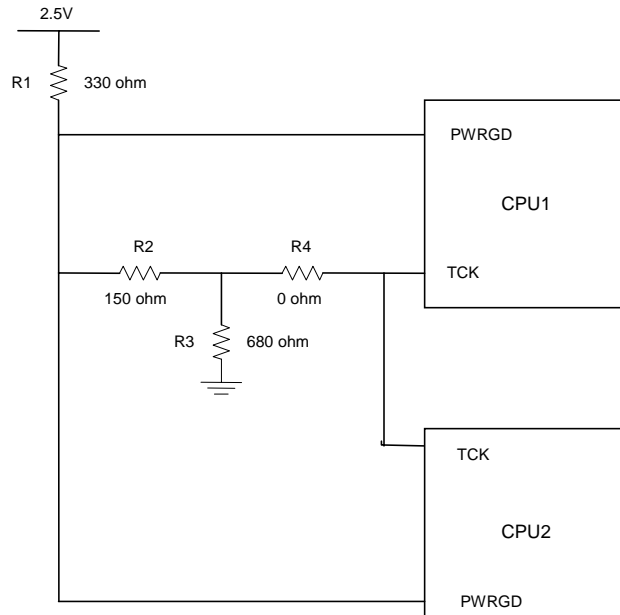
Pentium® III Processor with 512KB L2 Cache Platforms Workaround

Assumes the inputs to the CPU\_PWRGD are open collector signals that are Wire-ANDed together

- The example workaround circuit assumes that the PWRGD inputs into the processors are open collector. Tying the PWRGD inputs together in a Wired-AND fashion allows each processor to receive PWRGD at the same time but at the latter of the 2 separate PWRGD assertions. If separation of the PWRGD inputs to each processor is required, extra circuitry will be required.
